La Condesa Private Railroad Car

History of “La Condesa”

In 1989 work commenced on refurbishing and improving the car. Extensive modifications to the car's electrical, plumbing and heating systems were made during this hiatus. Repairs to the car body and other rusted out areas was also done at this time. A new toilet system was installed along with a holding tank.

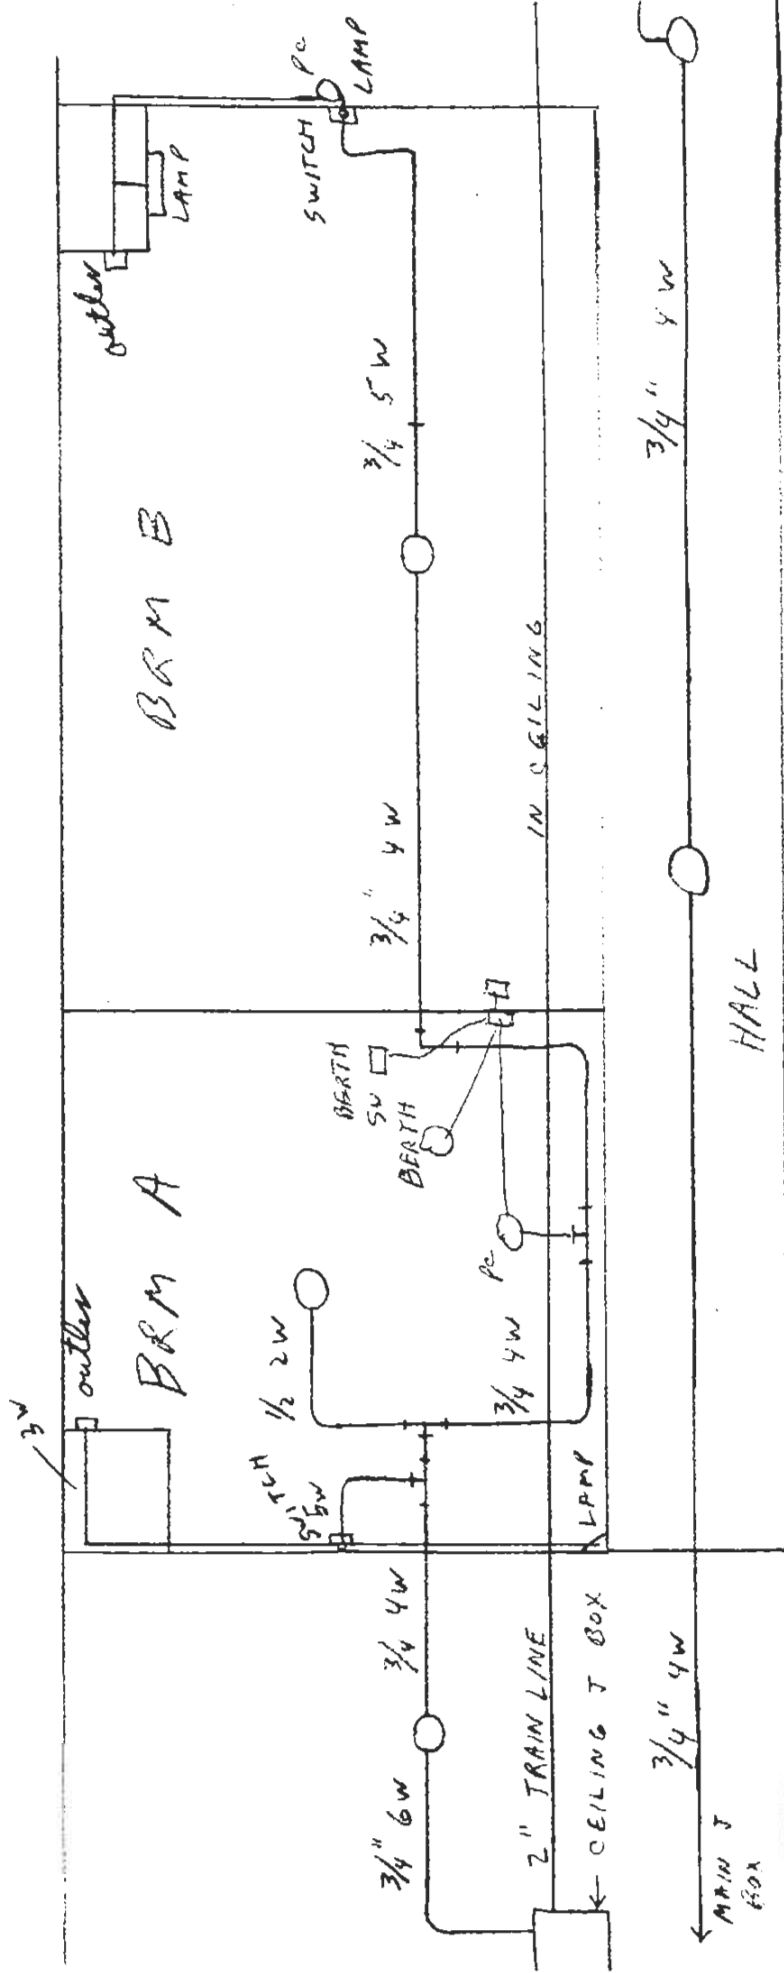
Fig 5

ceiling
CONDUIT LAYOUT

The main electrical conduit runs down the center of the ceiling. It runs from the circuit breaker (CB) panel at the Steward's section to the open platform of the car. Due to the installation of the air conditioning, a portion of this conduit had to be rerouted around the air conditioning (AC) unit to the bathroom side of the car and then back to the center of the lounge ceiling.

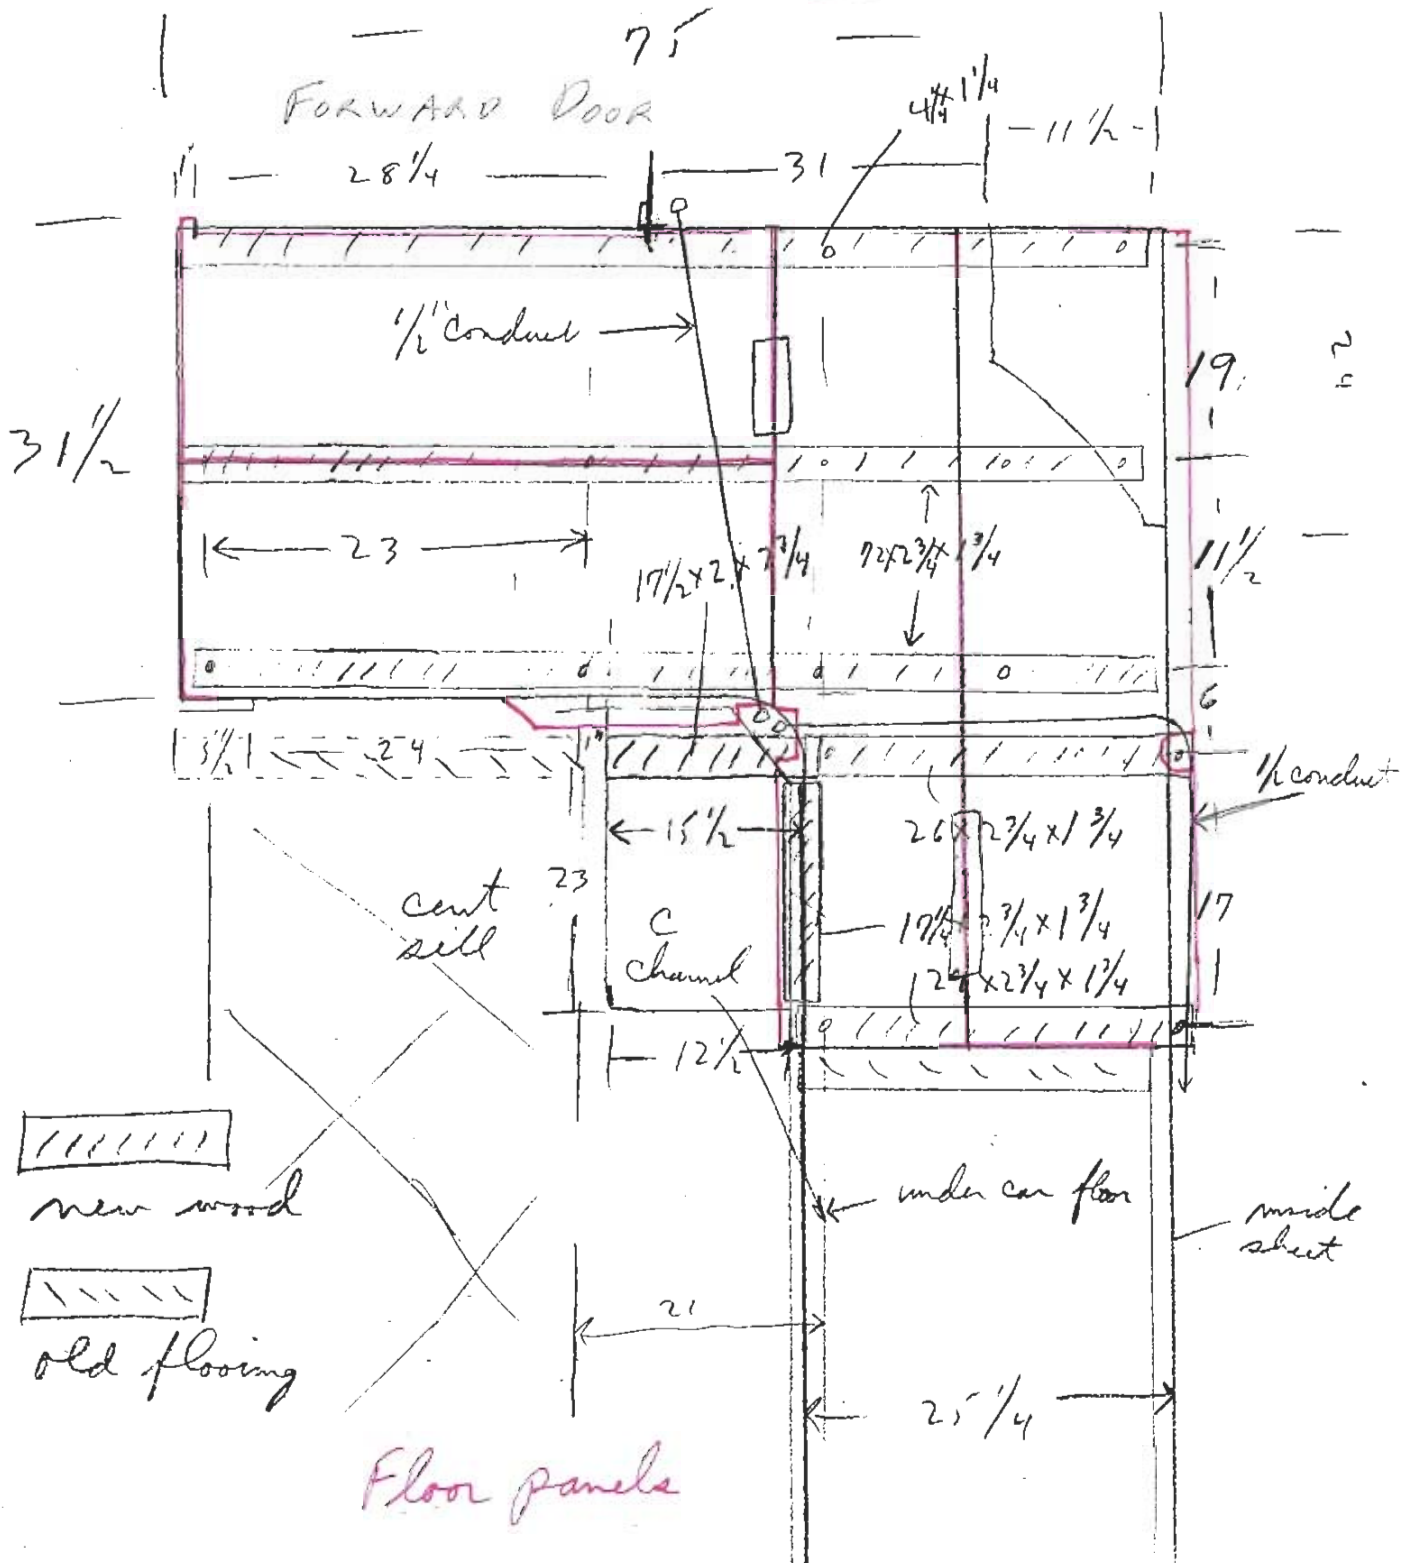
FIG 31 A

Rear Hallway floor spacing
FORWARD

After the ice box area was fixed, we then moved on to the forward hall of the car near the doorway. The flooring at this door, by the old kitchen, was also found to be in bad shape. Fig. 30 shows this hallway renovation near the forward door and the door to BRM A. The 1/2" conduit, shown on the floor, is for the forward door bell. In Fig. 31 are some more photos of this work. Fig. 31A is a floor plan showing the new work.

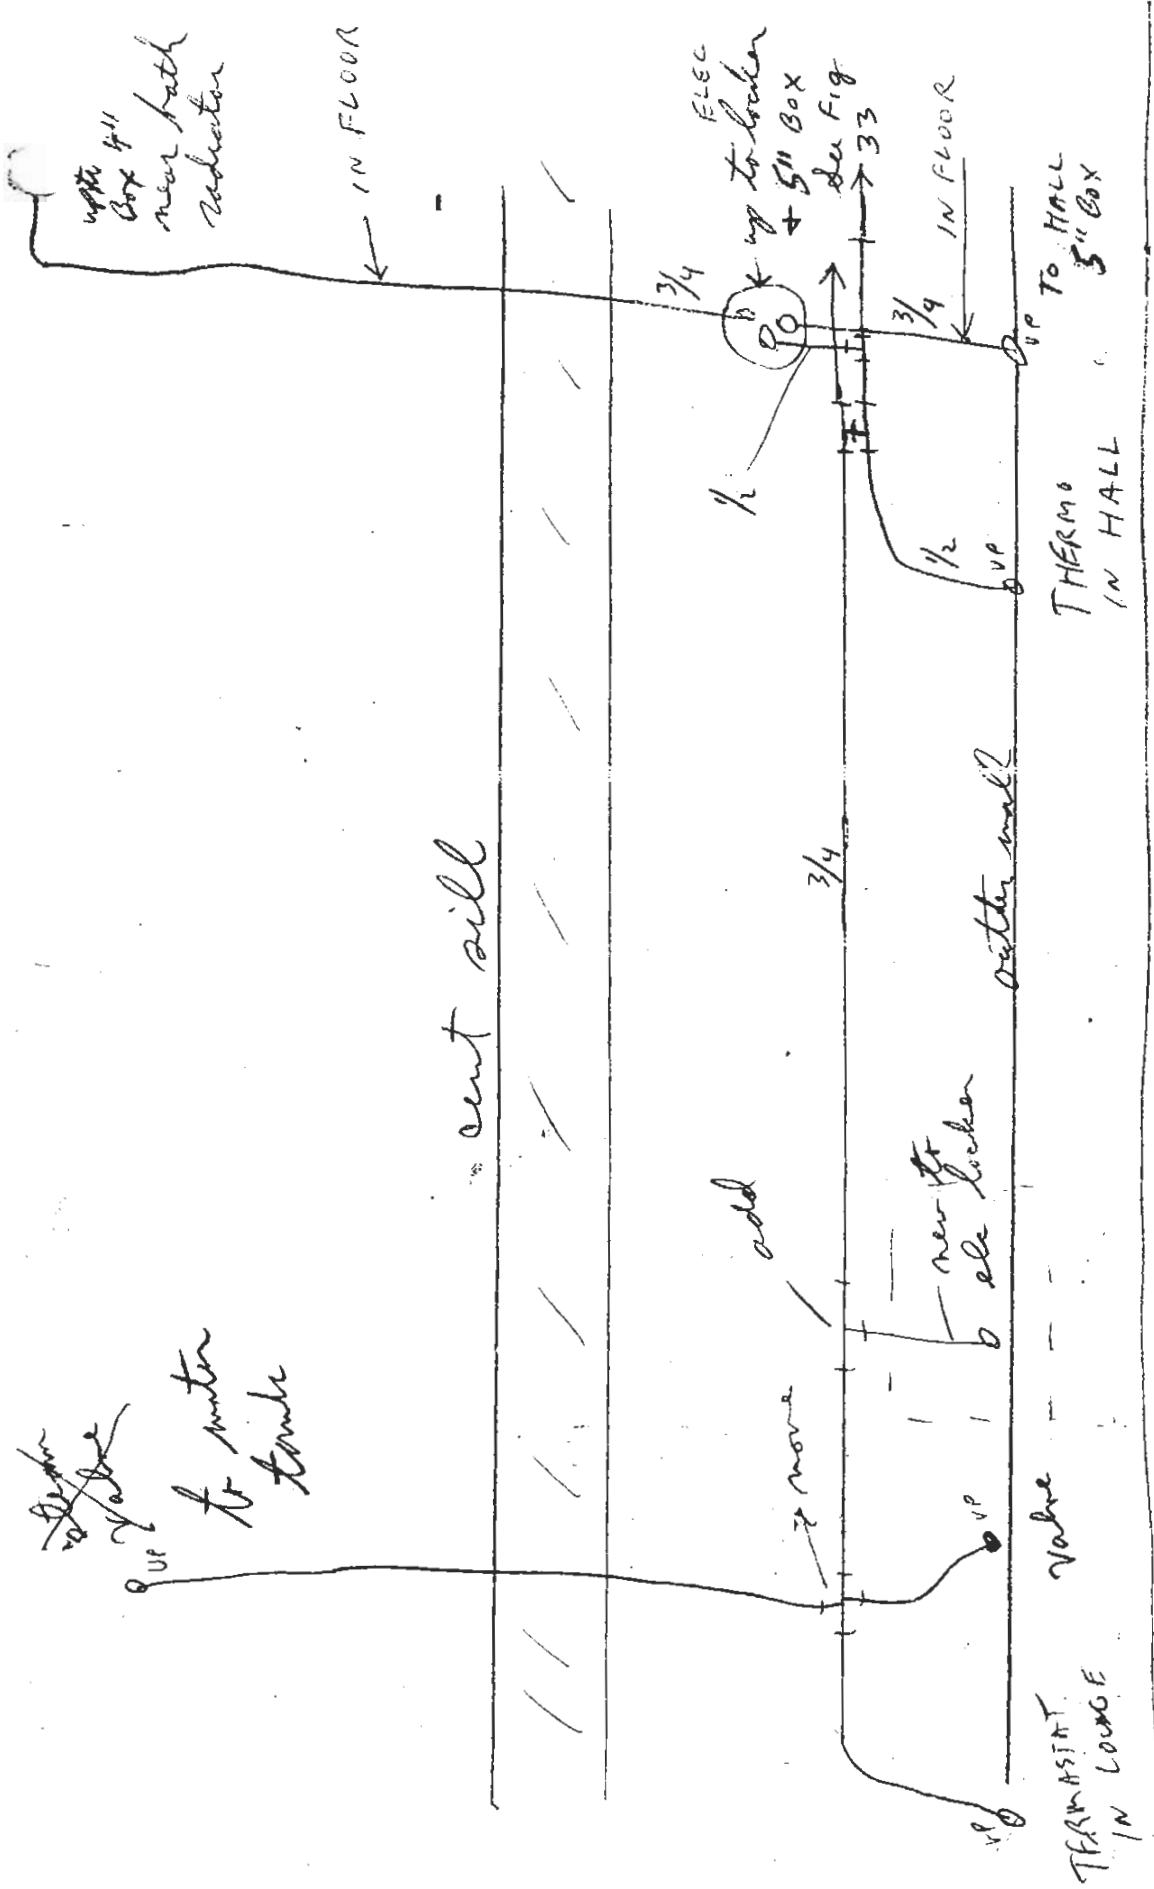
under car FIG 36

New AC heater + vented line

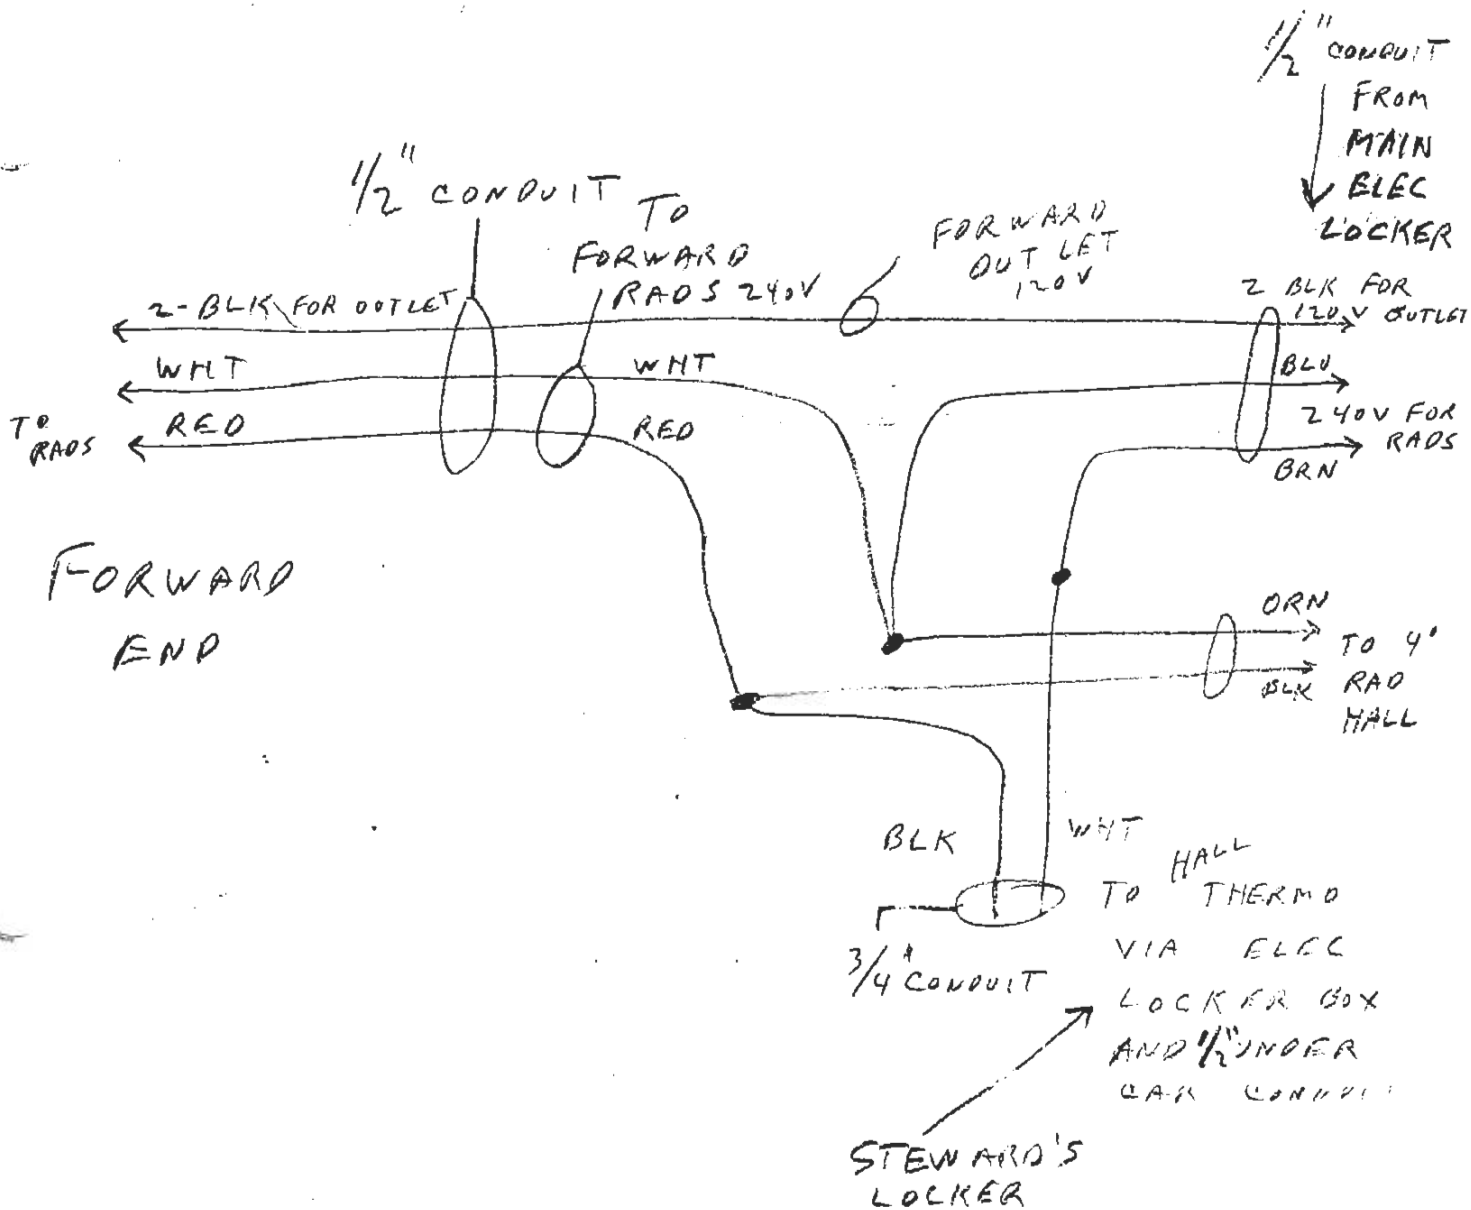
FIG 39A

HALL ELEC WIRING
AT OLD ICE BOX

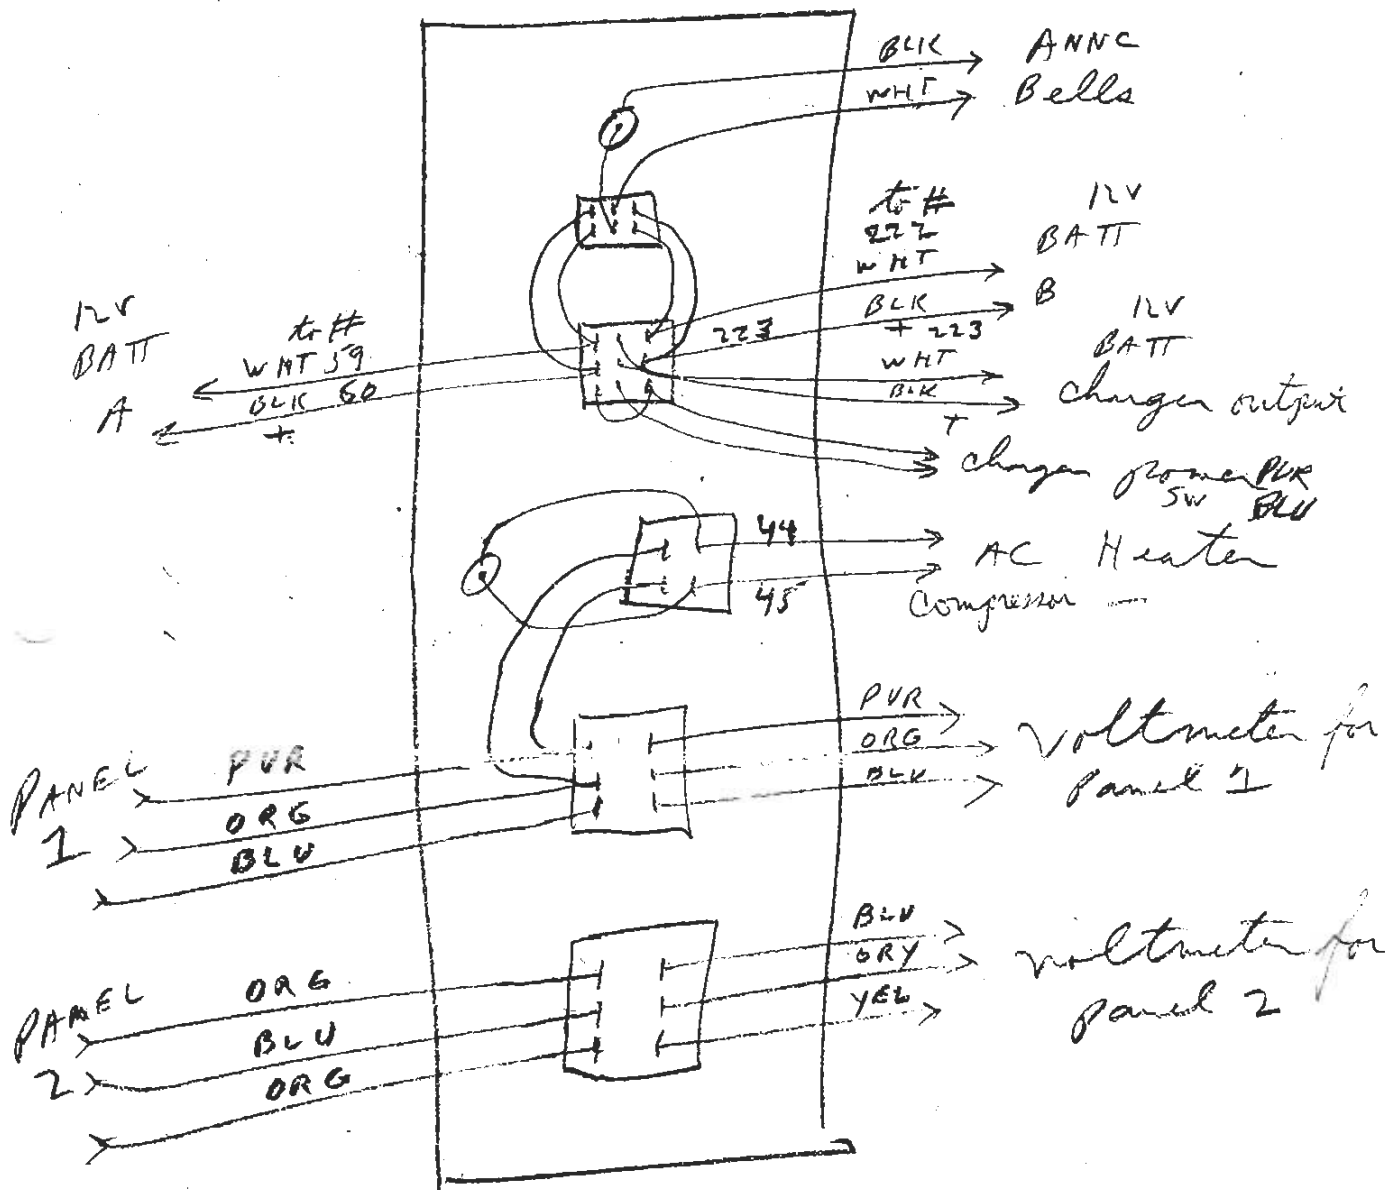
FIG 46A

Sub Panel wiring

The bottom two switches are small circuit breakers used to provide protection for the wiring to the two panel voltmeters. These voltmeters are positioned on the generator control panel located in the kitchen. In each of the two 240 volt CB panels there are ammeter shunts. This was provided so that the three phase current drawn by each panel can be observed. There are switches on the generator control panel to activate the various meters. See Fig. 46A for the wiring of this panel, and Figs. 46B and 46C for more wiring information.

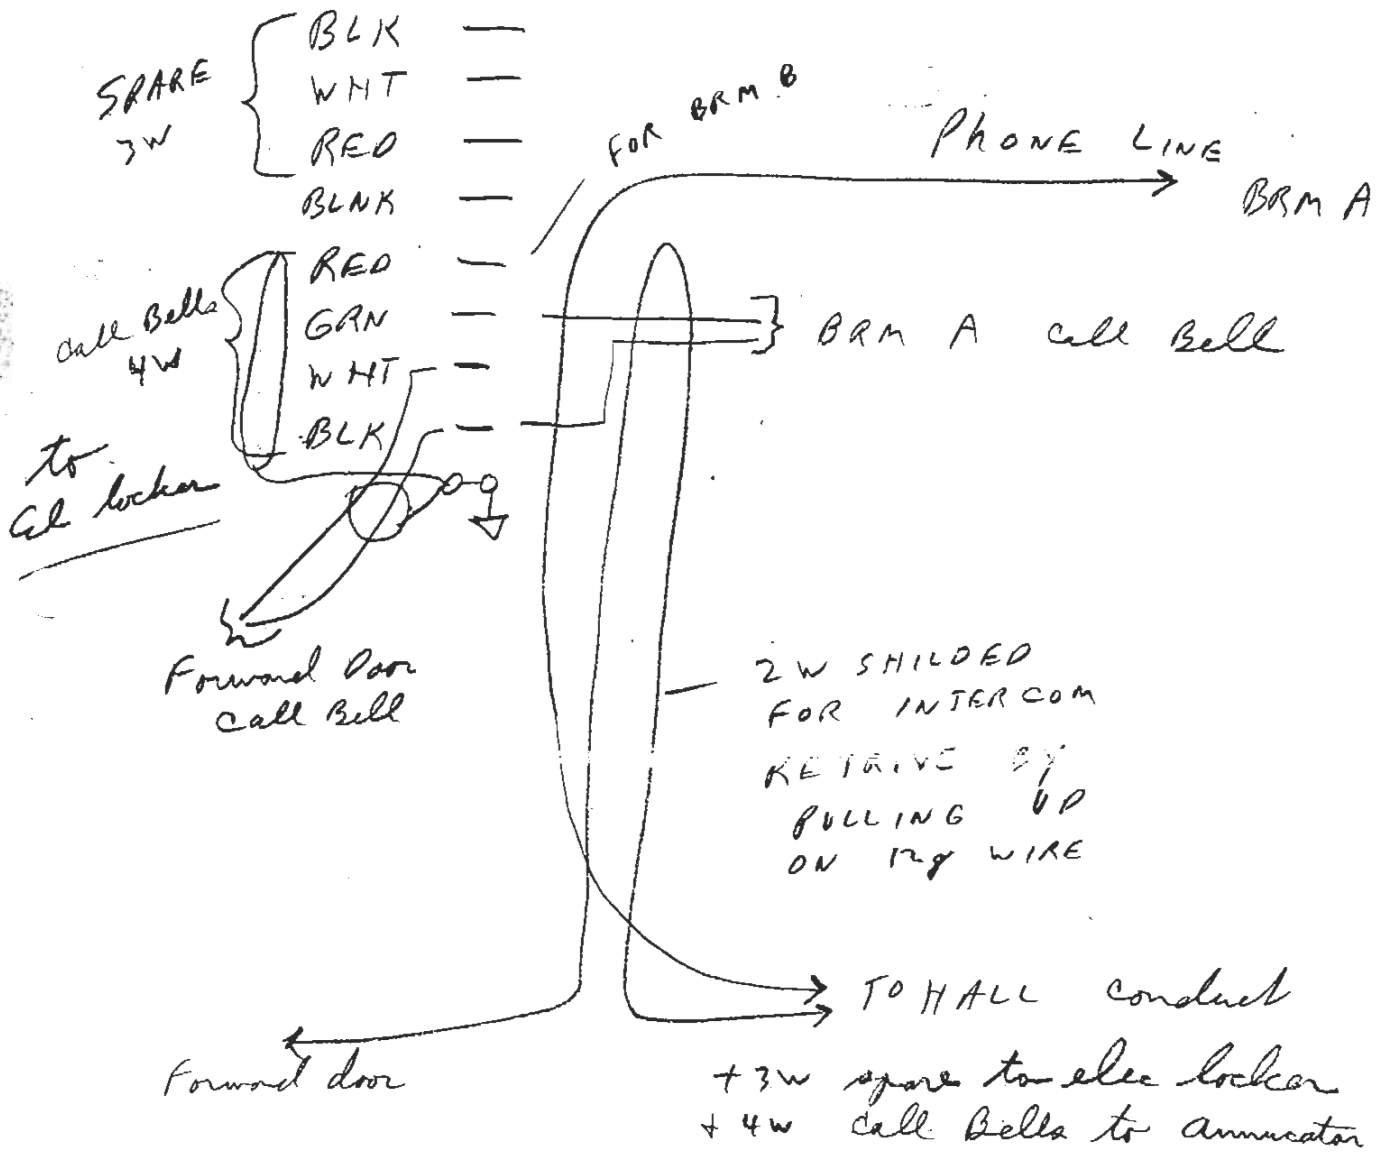
FIG 49A.

BRM A J BOX in cabinet

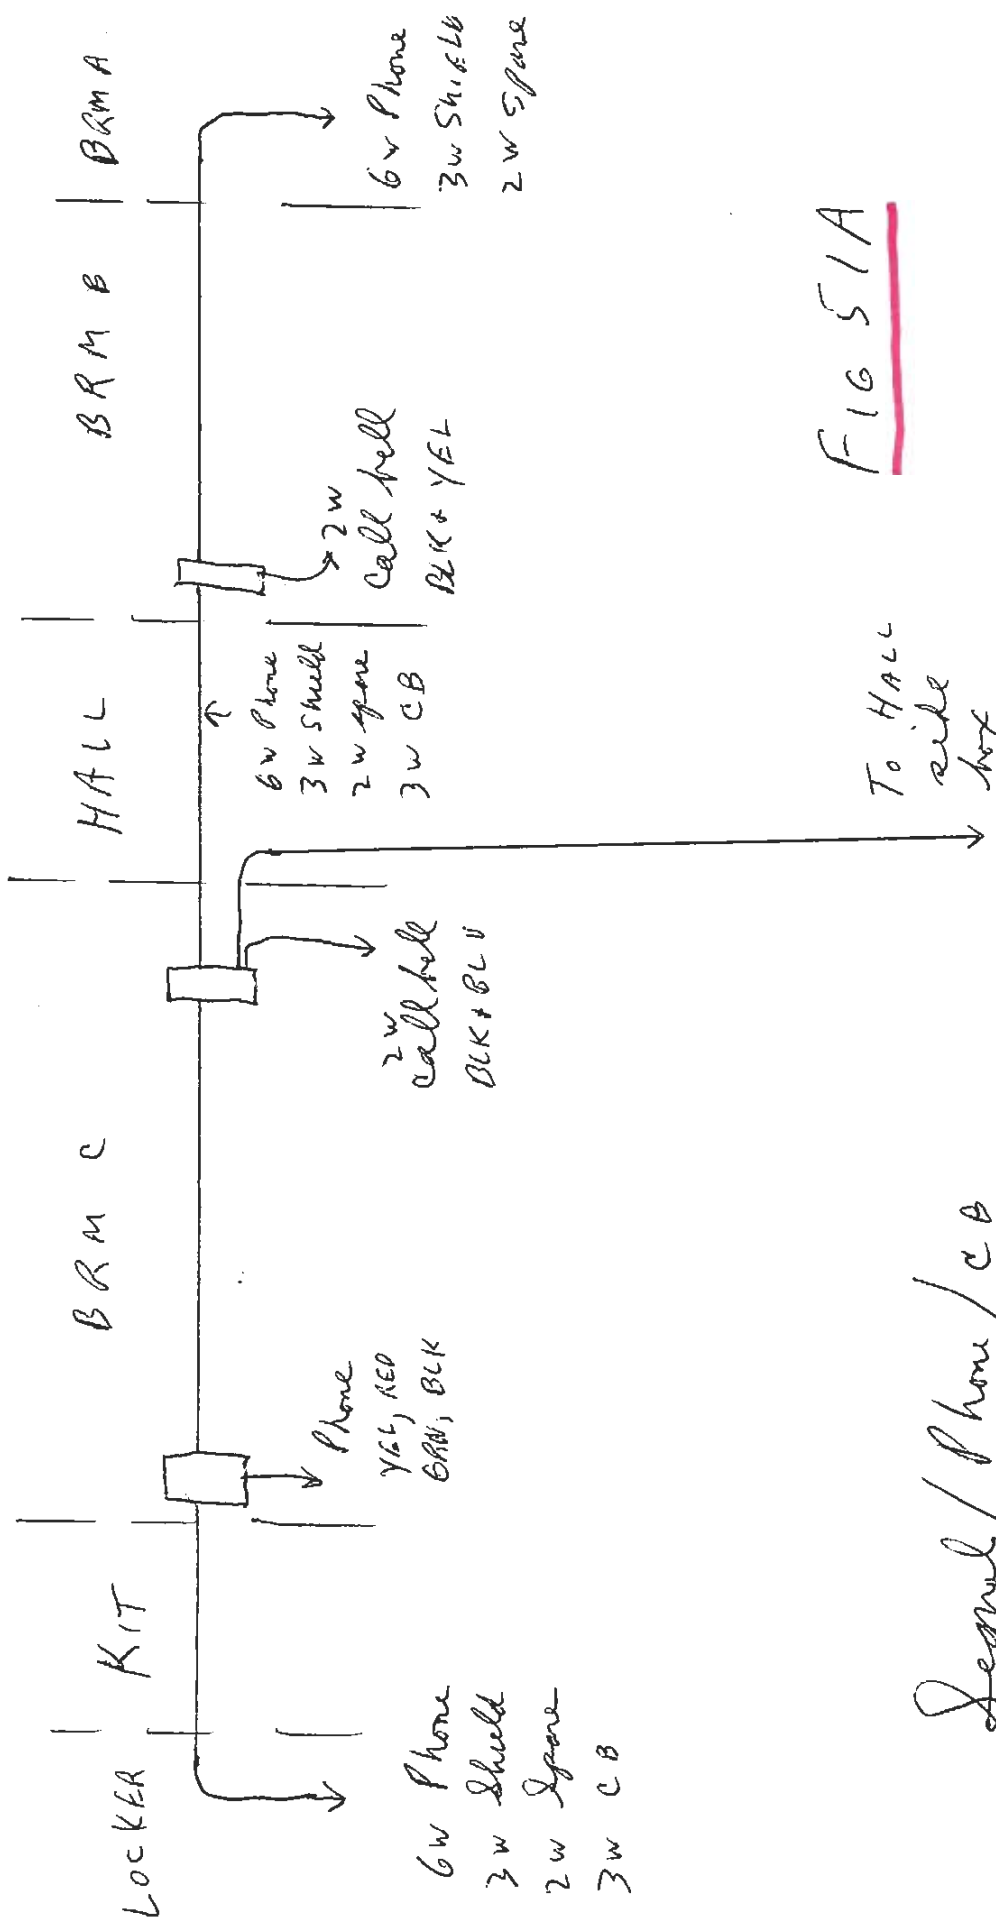
FIG 51A

Signal/Phone/CA
Lines
BER ROOM SIDE

One project that we undertook was to replace all of the plumbing in the car. We did not complete this job, but we did change out all of the plumbing from the kitchen to BRM A. More on this later. While we were at it, we also put in a communication conduit on the bedroom side of the car. See Fig. 51. This conduit contains four cables, a 6 wire telephone line, a three wire call bell line, a three wire shielded spare line, and a two wire spare line. See Fig. 51A for more details. To summarize, the call bell wires for BRM A are in the hall side conduit and the call bell wires for BRMS B & C are in the bedroom side conduit.

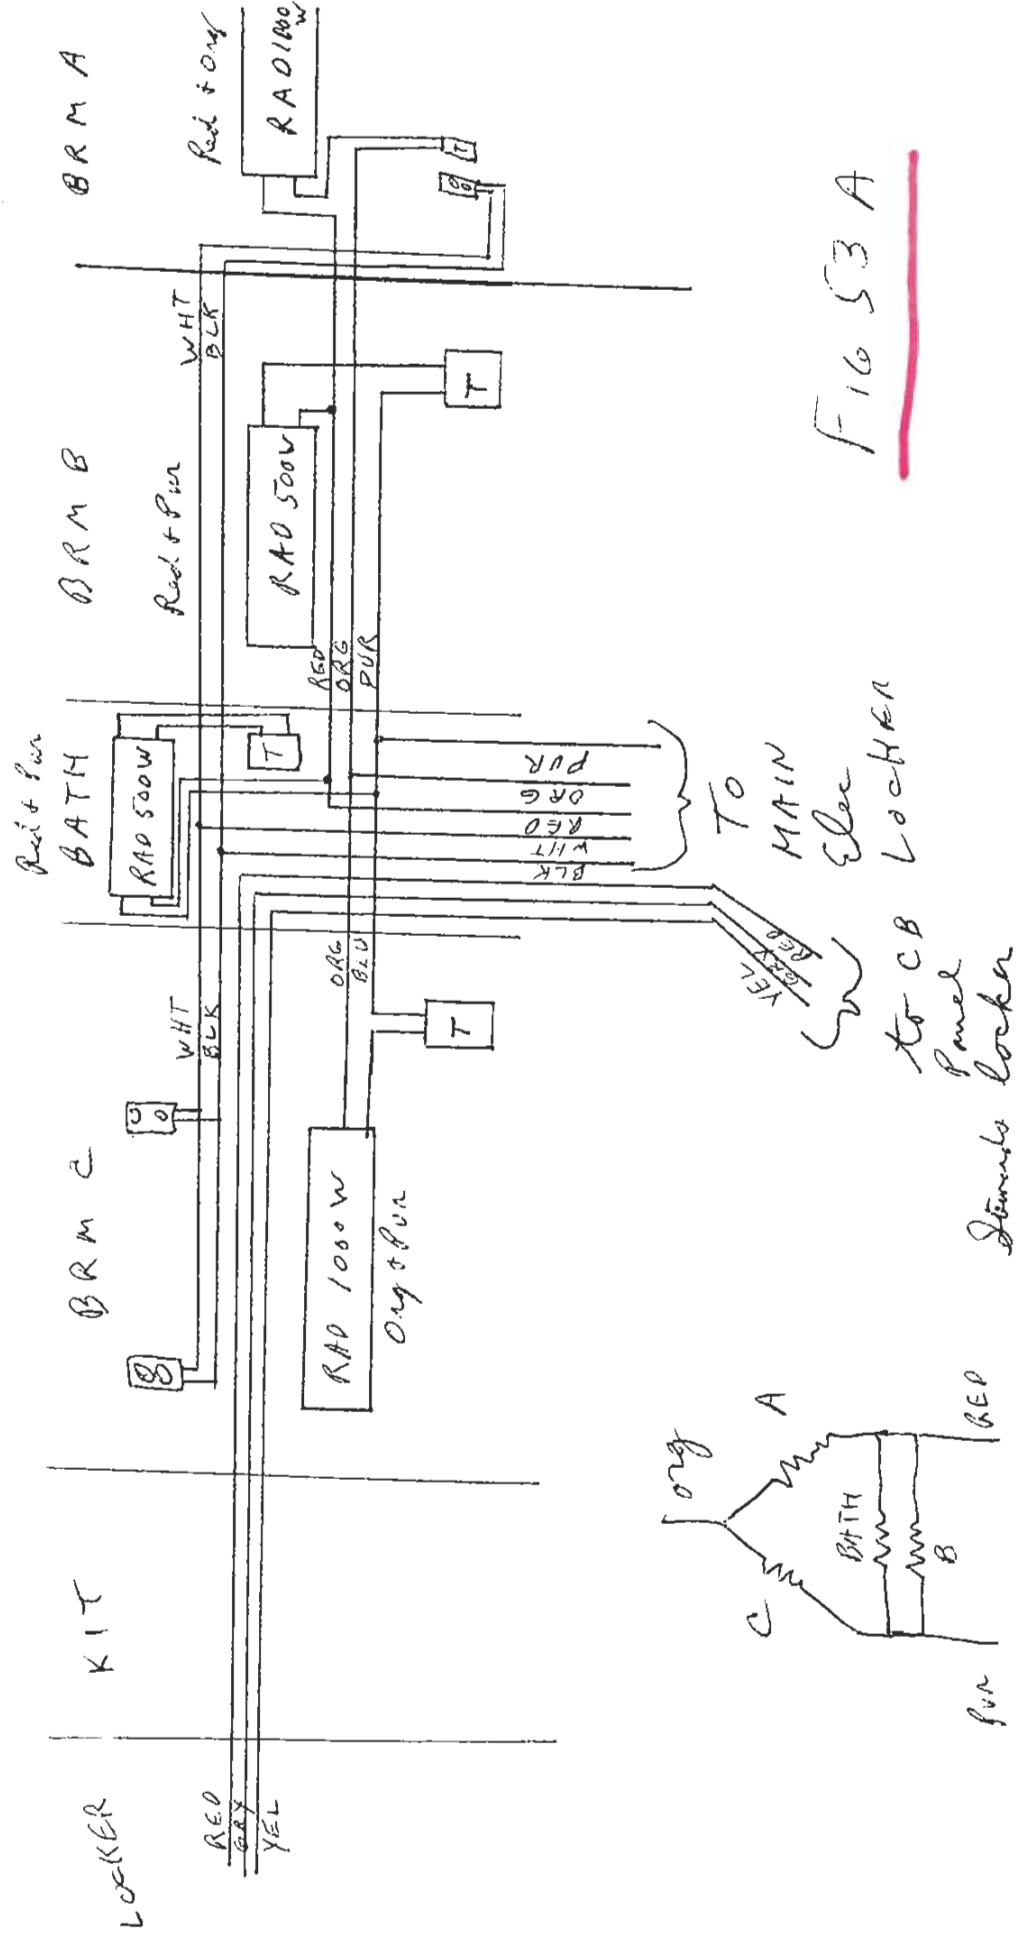
FIG 53 A

BEDROOM OUTSIDE WALL WIRING

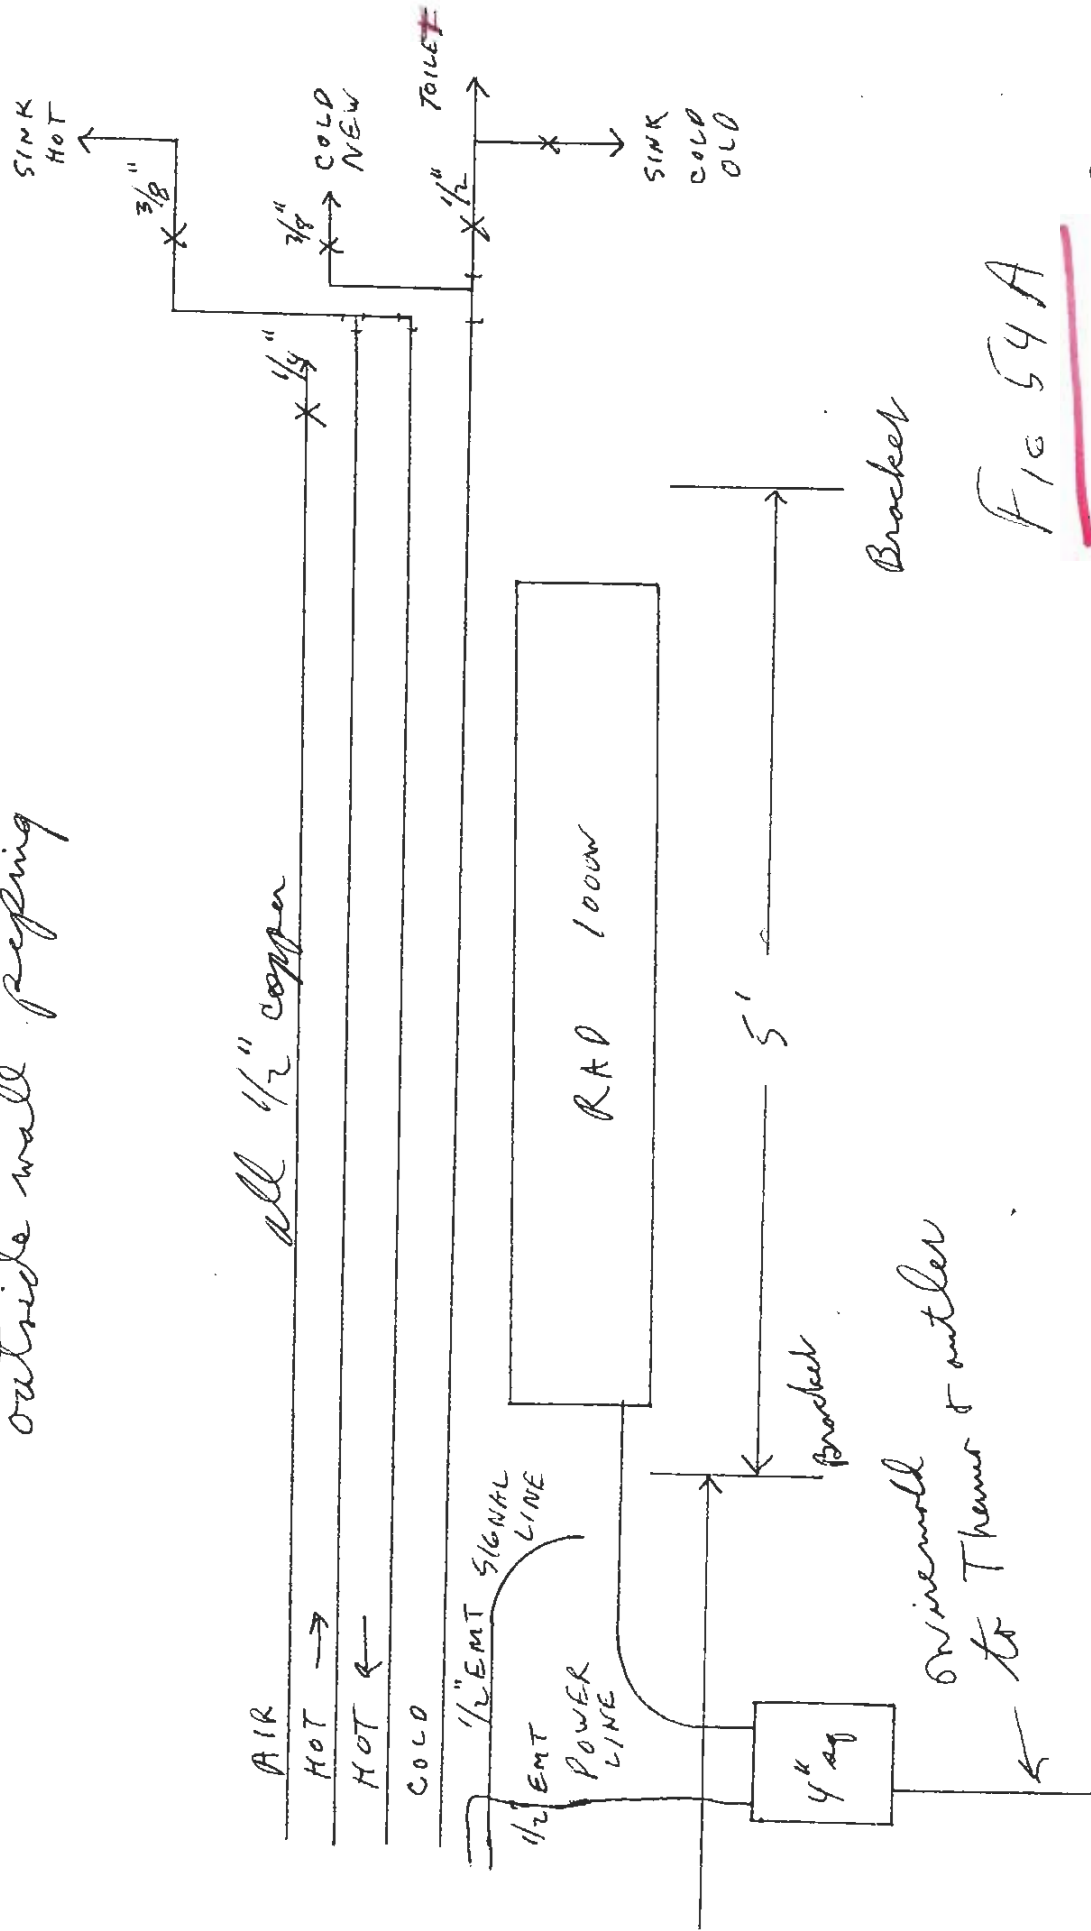
FIG 54 A

BRM A

outside wall piping

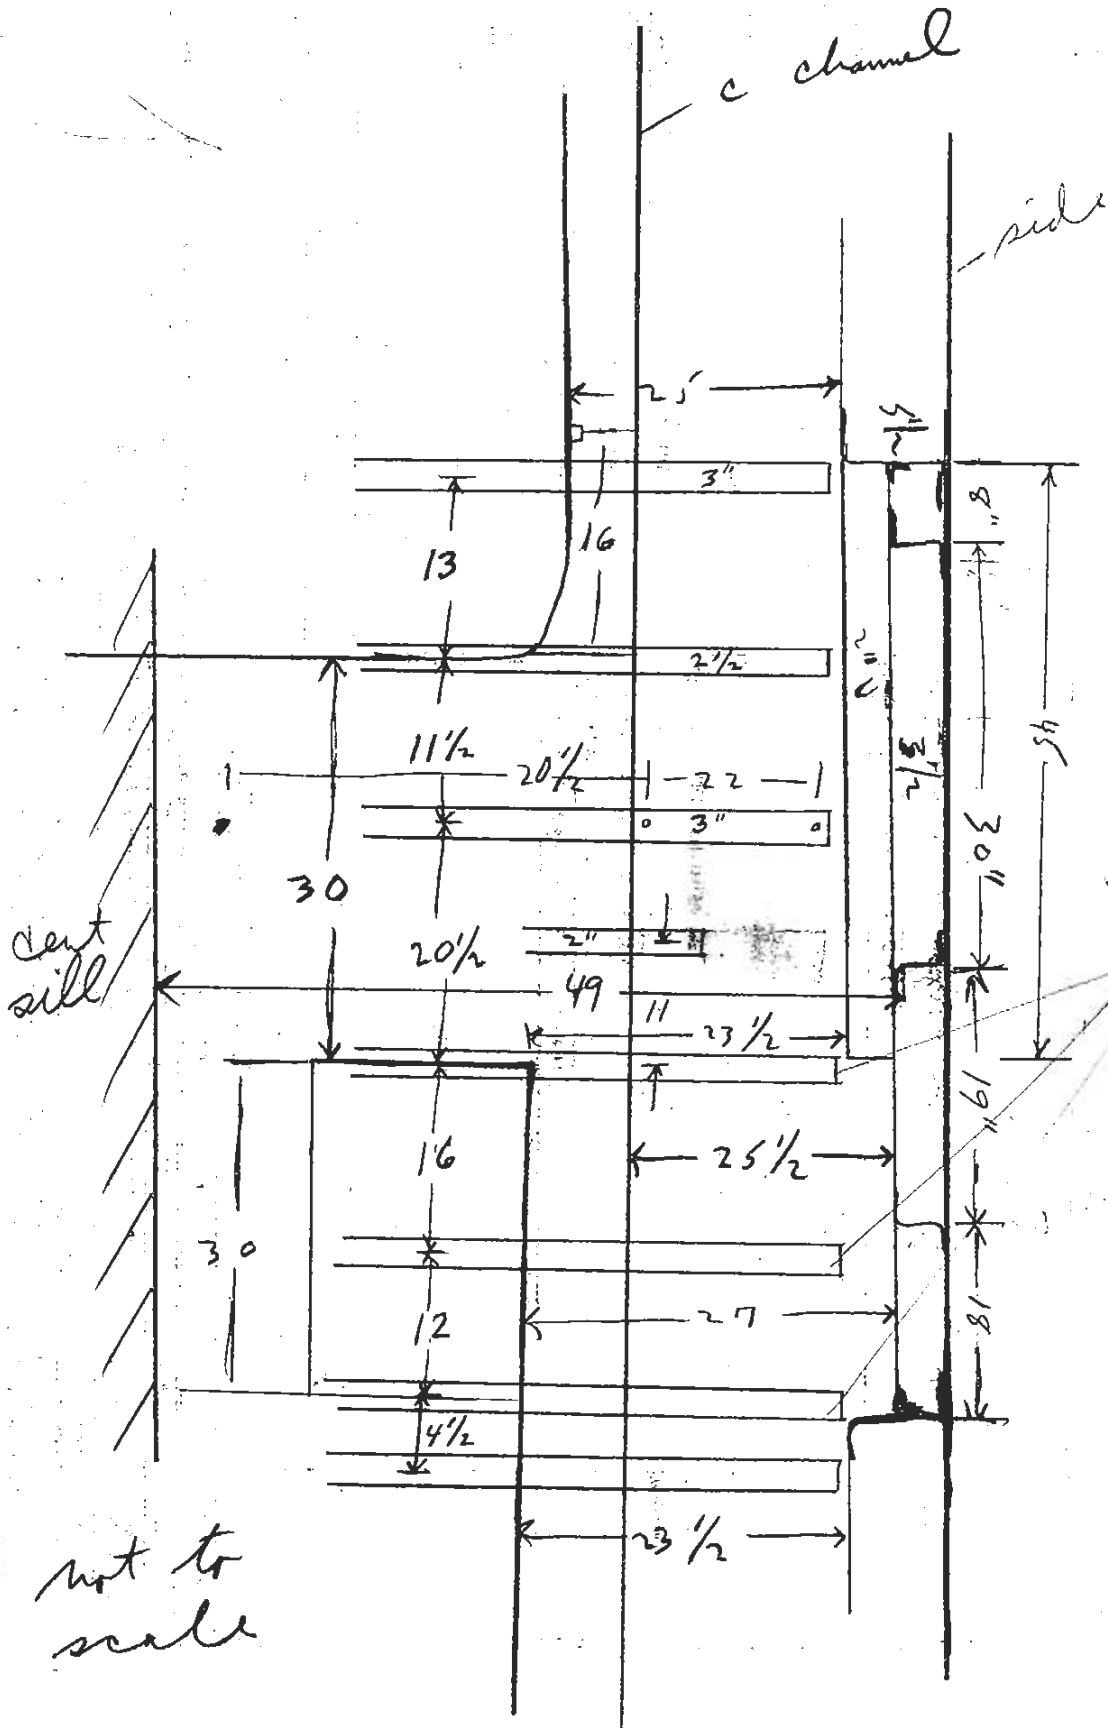
floor at
stowards
locker
with new
cross stringers

As we continued with this project, we realized that the damaged area was much larger than anticipated. The flooring under the Steward's electric cabinet, which was just behind the old ice box, was also compromised. See Fig. 28. The damage extended inboard as far as the door to BRM C. The board shown in Fig. 28 is the new replacement 2 3/4" by 2 3/4" beam to support the flooring. Note the rusted out floor over the center sill and the new replacement steel. (Middle and bottom photos) See the next three pages for more details on the replacement flooring.
